Document Title	List of known Issues of Secure	
Document Inte	Hardware Extensions	
Document Owner	AUTOSAR	
Document Responsibility	AUTOSAR	
Document Identification No	971

List of known Issues of Secure Hardware Extensions

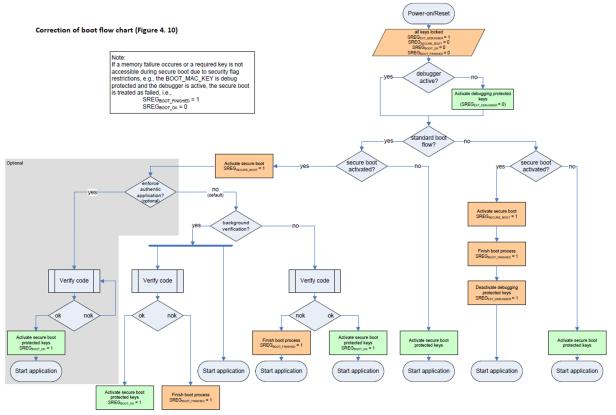
Figure 1: Correction of boot flow chart

No.	Date	Severity	Problem Description	Location
1	2009-07-31	erratum	CMD_EXPORT_RAM_KEY can also issue error code ERC_KEY_NOT_AVAILABLE.	Section 4.7.9 Table 4.6
			Note: The description of the command and the overview table were missing the information.	
2	2009-07-31	erratum	CMD_GET_ID may not issue error code ERC_KEY_NOT_AVAILABLE since key protection flags are not evaluated	Section 4.7.17 Table 4.6
			Note: The description of the command and the overview table indicate an error code that cannot be emitted by the command.	
3	2009-07-31	erratum	CMD_EXPORT_RAM_KEY reads UID Note: The command also needs to access the UID to calculate the	Table 4.4
			messages. The referenced table is missing the corresponding information (X = used by function).	
4	2009-07-31	erratum	The flag SREG.EXT_DEBUGGER has not to be set if the secure boot failed, see Figure 1 of this errata sheet for a corrected flow chart.	Figure 4.10
